**A.I.T.E.S.-ITA 2001 World Tunnel Congress
PROGRESS IN TUNNELLING AFTER 2000
Milano, June 10-13 , 2001**

***REHABILITATION OF HIGHWAY TUNNELS – TECHNIQUES
AND PROCEDURES***

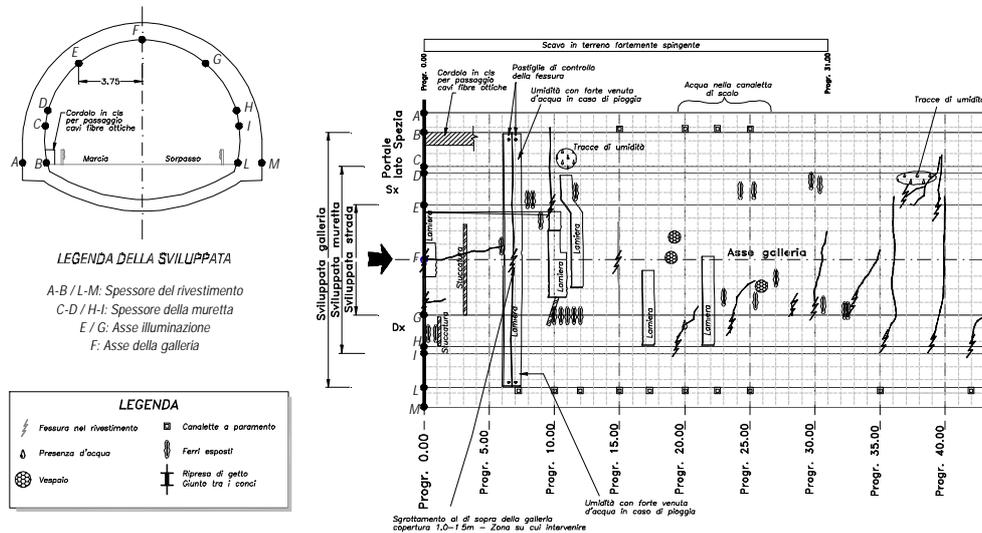
Visual inspection results are presented as a graphical field plot of defects. Such information is then entered into an AutocadTM file with GIS⁽¹⁾ referencing. Figure 1 shows a sample of the recorded graphical layout where defects are displayed as graphical symbols placed at their exact location along the crown. The symbols are linked to a database with a complete description of the defect. Symbols vary in size from small to large to indicate three levels of gravity of the defect (low, medium, and high, respectively). This system unites the capabilities of the GIS interface with the storage of a quantity of information that could not be handled otherwise. The search for a specific defect type is then possible via queries, and any rehabilitation work is incorporated into a historical record in order to provide a time series as basis for the maintenance schedule of each inspected tunnel.

Figure 1 Typical inspection results presentation

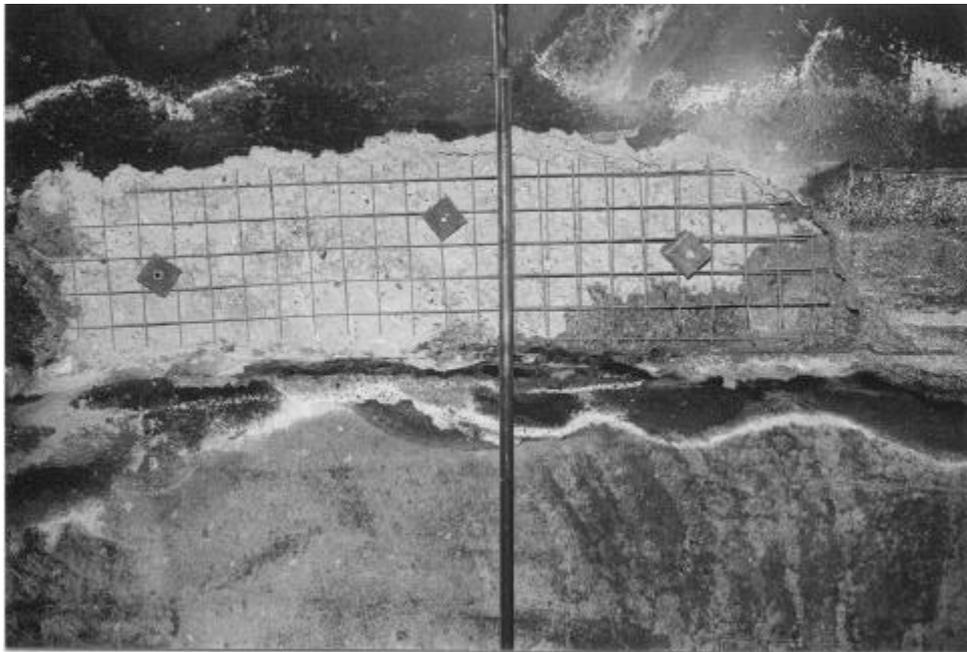
The *case history of the Albiano Tunnel* provides an example of localised light rehabilitation. During the preliminary inspection of the tunnel lining, comprising visual inspection and hammer tests, several instances of superficial lining deterioration, rebar corrosion, faults in the cement, voids and weathering were detected. These damages were

- a) air pumps, used to pump concrete, caused separation of the gravel from water and cement. For this reason non-homogeneous concrete created zones with honeycombed concrete and other sections where only the superficial layer is well-mixed and compact;
- b) plastic drainage channels were covered by cement lacking wire mesh and thus at risk of cracking;
- c) time delays between concrete pumping intervals in some sections resulted in separation boundaries (cold joints);
- d) only the section nearest the tunnel entrance was made with reinforced concrete.

Figure 2 - Honeycombed concrete demolished and reconstructed using welded wire mesh and dry-mix shotcrete

The degree of lining weathering was evaluated by collecting 10 core samples (ϕ 101 mm). The zones identified as having defects were demolished by jack hammering. In cases of deeply honeycombed concrete or disconnected concrete sections more than 20 cm thick, two layers of welded wire mesh (ϕ 10 mm, 200 x 200 mm) were placed as shown in Figure 2, fastened to the sound concrete with rock bolts perpendicular or parallel to the surface. In cases of shallow honeycombed concrete, a single mesh layer (ϕ 5 mm, 100 x 100 mm) was sufficient to re-establish the original surface.

Once the welded wire mesh was fastened, the area was recovered with dry-mix, rapid-set shotcrete. Shotcrete had aggregates of 0-5 mm, additives to guarantee a good adhesion to the previous concrete surface and high waterproofing characteristics. It also provides good resistance against sulphates, which was also required for the highly aggressive tunnel atmosphere.

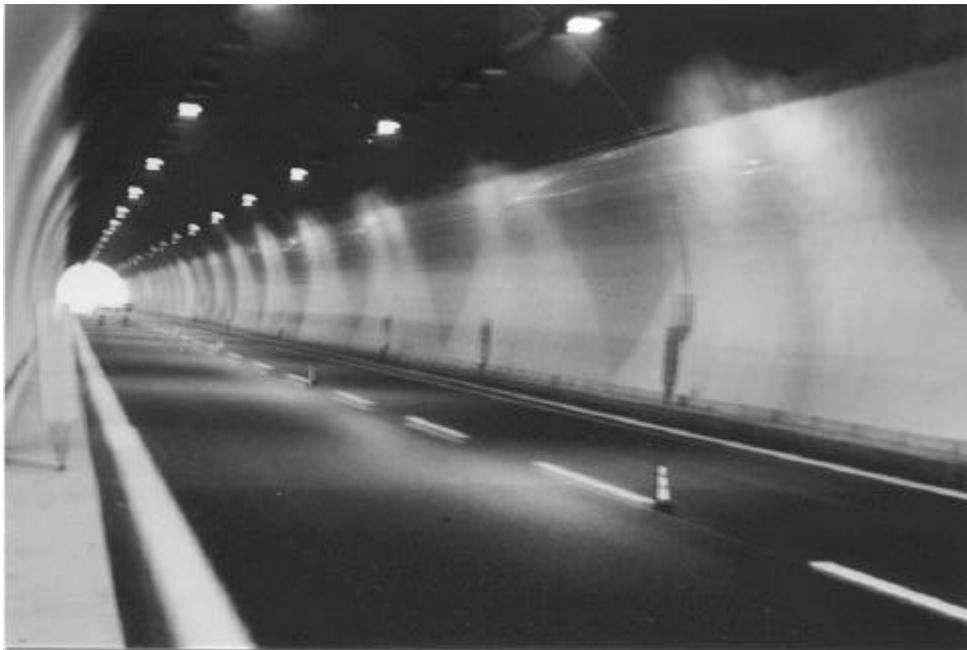
The 350 metre long Casacca twin tunnel was initially investigated in June 1996 and the decision to proceed with definitive rehabilitation was taken in 1999. Tunnel lining thickness and lining stress/strain status were assessed in the initial investigation. It appeared that the stress on the lining was not due to thrust from the surrounding soil. Numerous voids were found above the crown, which was anyway already supported by steel ribs and shotcrete from the original tunnel construction work. A monitoring system (using electronic vibrating wire crackmeters) was installed to verify opening of existing cracks. No relevant movements were recorded over the 3-year monitoring period (1996-1999).

Figure 3 - Casacca tunnel after lining surface rehabilitation.

The above activities were executed in the year 2000 and the Casacca Southern Tunnel is now fully functional as shown in Figure 3.

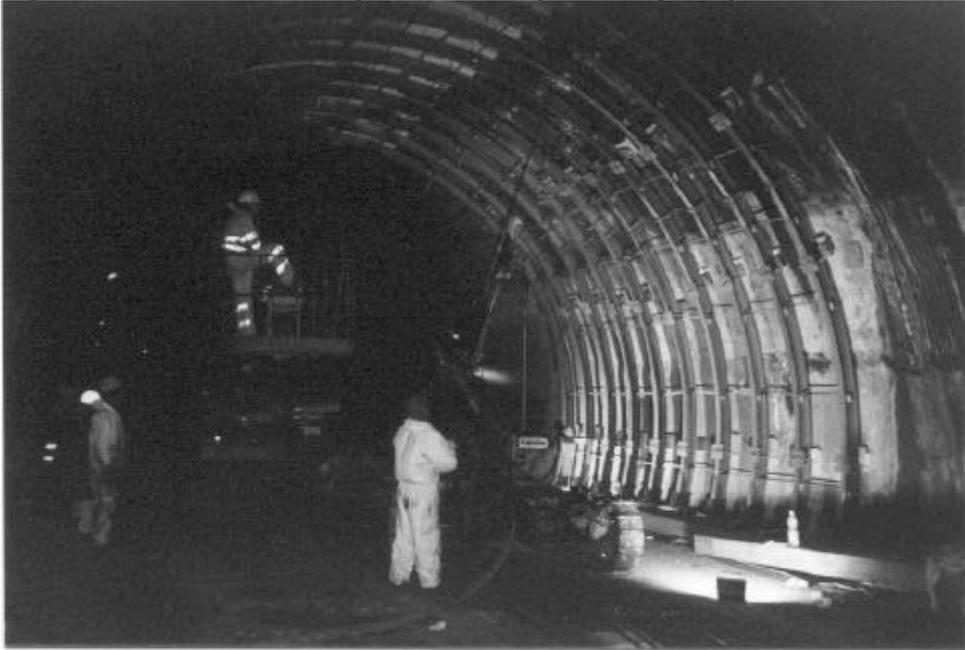
The entire preliminary inspection (visual inspection with hammer tests) was carried out in one week. The investigation recorded 153 points with superficial lining deterioration and weathering, cracks in the concrete lining, and leaks. In addition, three critical situations were revealed just via visual inspection and hammering: two sections presented voids between the temporary and permanent supports and insufficient thickness of the existing lining; in addition another section had a cavity more than 2 m deep above the lining, linked to a possible fault zone encountered during tunnel construction.

Figure 4 – Rock bolt installation under protective steel ribs

PHASE 1: Removal of provisional support used for temporary repair. Installation of coupled IPN 180 steel ribs (see Figure 4) and fixing of existing lining with rock bolts.

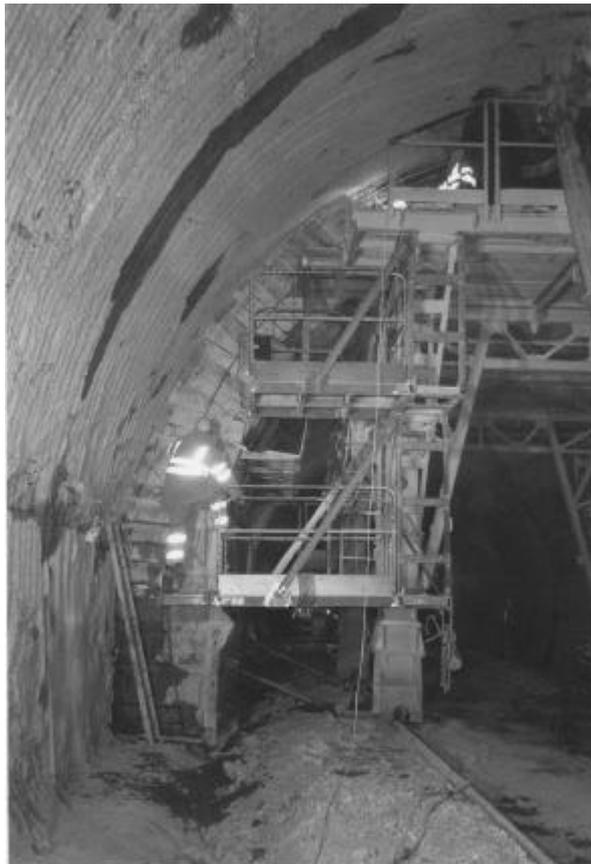
The 300 m long Corchia twin tunnel was constructed through a Flysch geological formation during the seventies. During the eighties, transversal and longitudinal cracks developed (up to 50 mm wide) in the concrete lining near the middle of the tunnel. A small stream, Rio Bosco Secco, runs parallel to the tunnel for about 300 m.

The interpretation of investigation data as well as data collected through further monitoring revealed a slipping surface close to the fault area. Displacement of the rock mass was continuous, with periodical movements associated with water table level variation due to infiltration from the surface water drainage system.

Figure 5 – Concreting phase

involved creating a stiff reinforced concrete annular segment located crosswise to the fault zone. The adopted design concepts for work in a dangerous area were verified using a finite element method to ensure adequate protection and safety.

PHASE 5 Demolition and reconstruction of sidewalls and crown. Demolition was performed by means of a head-scraper removing 50 cm thickness from existing damaged lining in 9 m sections. The operation was protected by the previous Phase 2 treatment. Steel reinforcement was installed in 6.5 m sections. Hydraulic operated formwork was installed employing theodolite measurement for correct tunnel alignment. Concreting was performed using R_{ck} 30 MPa grade concrete by means of pumps and vibrators connected directly to the hydraulic formwork.
