# A Consistent Approach to the Structural Rehabilitation of Tunnel Liners

Livio Locatelli, Giorgio Borgonovo  
*Golder Associates, Milan, Italy*

**ABSTRACT:** The concrete liners of existing tunnels could present relevant damages due to their ageing or weathering, or to improper construction techniques. In some cases, depending on the geological conditions, these faults are due to the overstress caused e.g. by the occurrence of landslides, by swelling or creep of the rock mass, etc. Whilst two-dimensional numerical models are in most cases sufficient to assess the stress-strain state within the liner, a proper analysis of its replacement should be based on three-dimensional calculations. They, in fact, permit evaluating the need of soil/rock treatments around the tunnel and the length of the tunnel portions in which the liner demolition and re-construction can be safely carried out. In addition, they are necessary for a proper design of the new reinforced concrete support. Three level of tunnel rehabilitation are discussed, ranging from light repairs of the inner surface of the liner to heavy structural changes involving its demolition and reconstruction. Some case histories rela

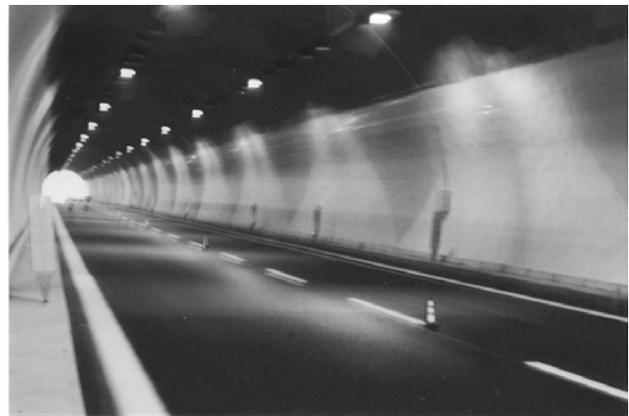
Fig. 3. Casacca tunnel after the rehabilitation of its lining.

The restoration of south tunnel was completed in the year 2000, and in year 2001 for north tunnel. Presently Casacca twin tunnels are fully functional as shown in Fig. 3.
